COAL CAR HISTORIC RECONSTRUCTION

The Deconstruction of the Coal Car

March 14, 2008

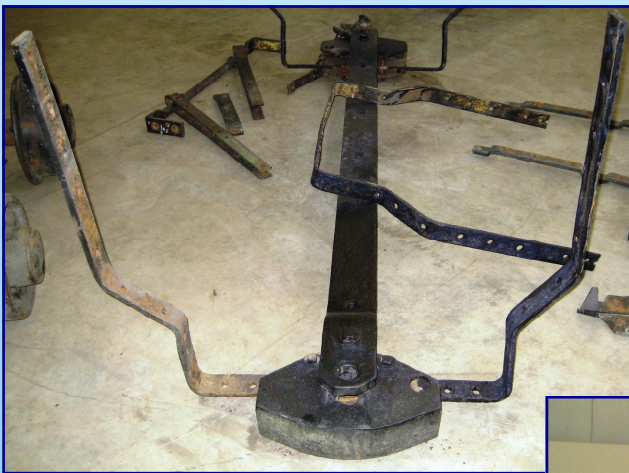
the metal so that it will no longer be susceptible to corrosion. After the metal has been coated with the primer, a new coating of black paint will be applied. The photo at left shows a portion of the metal frame undergoing treatment. The vertical bar on the left has not yet been treated and is still covered in rust. The center portion and right vertical bar have had the rust removed and primer applied.

The treatment of the metal frame and truck of the coal car involves brushing off the current coating of rust and applying a new primer. This new primer is black and chemically changes the surface of
