COAL CAR HISTORIC RECONSTRUCTION

Douglas Fir Was The Best Choice

May 20, 2008

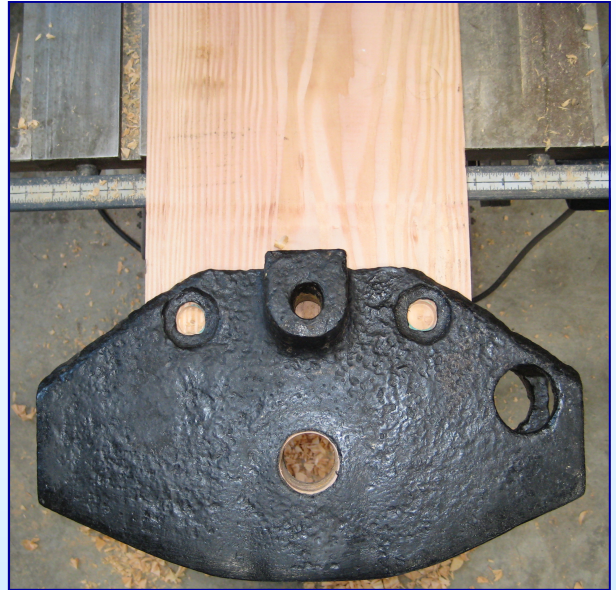
The center board fitted into the metal end piece.

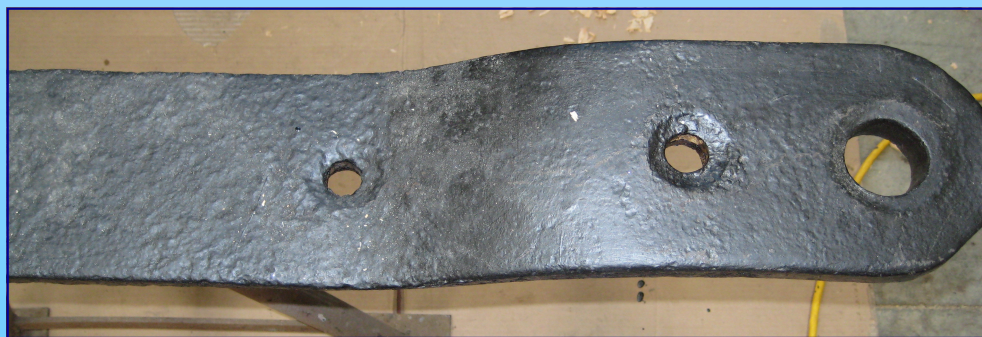
Bill also noticed an interesting wear pattern around the holes for the bolts that held the wood to the bottom iron cross-piece. This concave wear probably resulted from years and years of coal dust, water, and car jostling. Washers will cover this wear when the car is completely reassembled, but this hidden deterioration is another indication of the hard use these cars got in the mines.

Wear caused by years of hard use is visible around the edges of all three bolt holes shown on this metal frame piece.
