Renton Historical Museum - RFQ Questions and Responses

Addendum One - August 1, 2025

**Renton Historical Museum Remodel
235 Mill Avenue South
Renton, WA 98057**

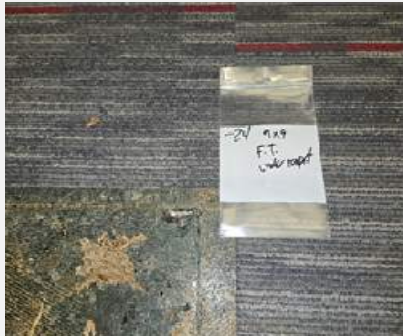
Asbestos Sample		Sample Date: 13-Nov-2024	
Project Name	Renton Historical Museum Remodel		
Sample Type	Physical Sample	AHERA Category	Miscellaneous
Sample Number	24	Homogeneous Material #	16
Material Description	9x9 Floor Tile and tar mastic		
Building Component	Floor	Substrate	Concrete
Homogen. Mtl Area	N/A		
Sample Location	Room 104 under carpet tile		
Quantity	300	Unit of Measure	Square Feet
Asbestos Type/%	Layer 1: (Yellow Mastic) None Detected Layer 2: (Green Floor Tile) Chrysotile 3-5% Layer 3: (Black Mastic) Chrysotile 3-5%		
Sample Photo

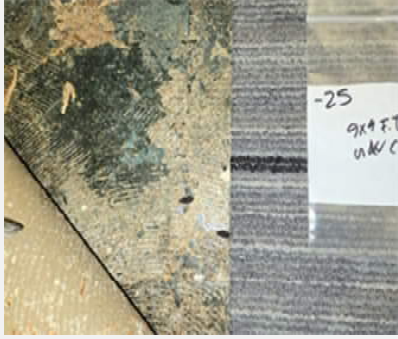
Asbestos Sample		Sample Date: 13-Nov-2024	
Project Name	Renton Historical Museum Remodel		
Sample Type	Physical Sample	AHERA Category	Miscellaneous
Sample Number	25	Homogeneous Material #	16
Material Description	9x9 Floor Tile and tar mastic		
Building Component	Floor	Substrate	Concrete
Homogen. Mtl Area	N/A		
Sample Location	Room 101		
Quantity	See 24	Unit of Measure	Square Feet
Asbestos Type/%	Layer 1: (Yellow Mastic) None Detected Layer 2: (Green Floor Tile) Chrysotile 3-5% Layer 3: (Black Mastic) Chrysotile 3-5%		
Sample Photo

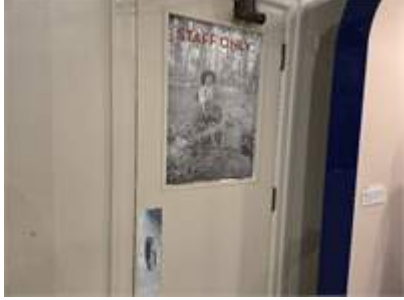
Lead Samples	
Sample Number	-122
Calibration	No
Substrate Description	Wood
Component	Door trim
Color	Beige
Sample Location	Room 1
XRF Reading (Mg/cm2 lead)	1.92
Result	Positive
Sample Photo

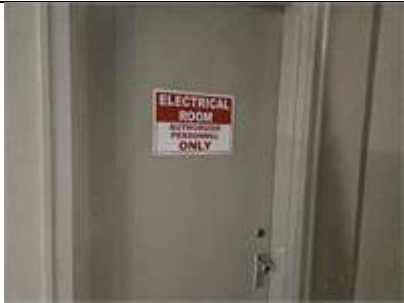
Lead Samples	
Sample Number	-124
Calibration	No
Substrate Description	Wood
Component	Door
Color	Beige
Sample Location	Elec Room
XRF Reading (Mg/cm2 lead)	1.59
Result	Positive
Sample Photo

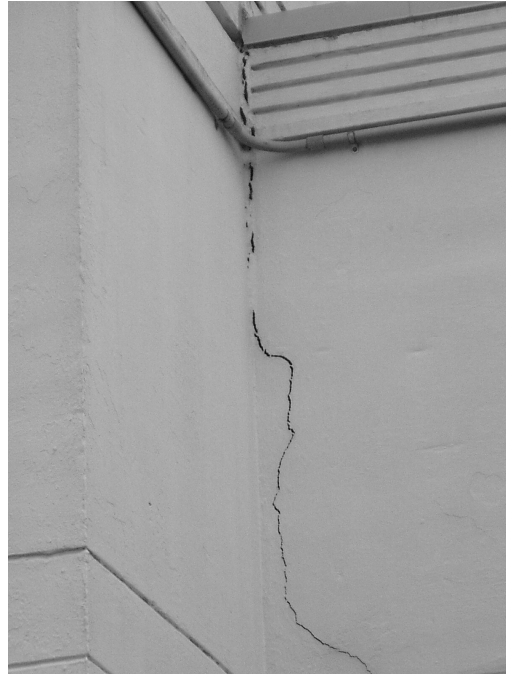
**Crack at wall, 2007. Hose tower at left.
Photo by author.**

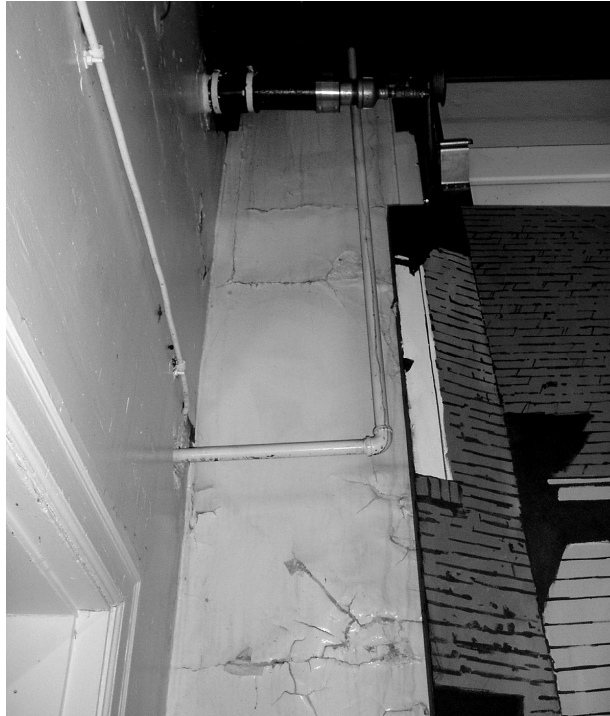
**Efflorescence at west wall near overhead door
causing paint to blister & crack.
Photo by author.**

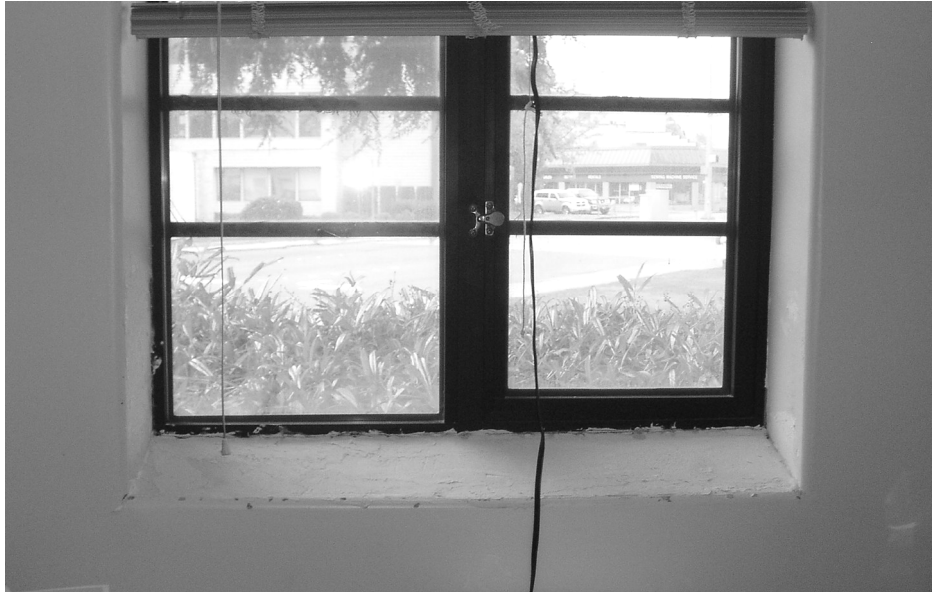
**Window at workroom, typical, showing spalling finish at window surround.
Photo by author.**

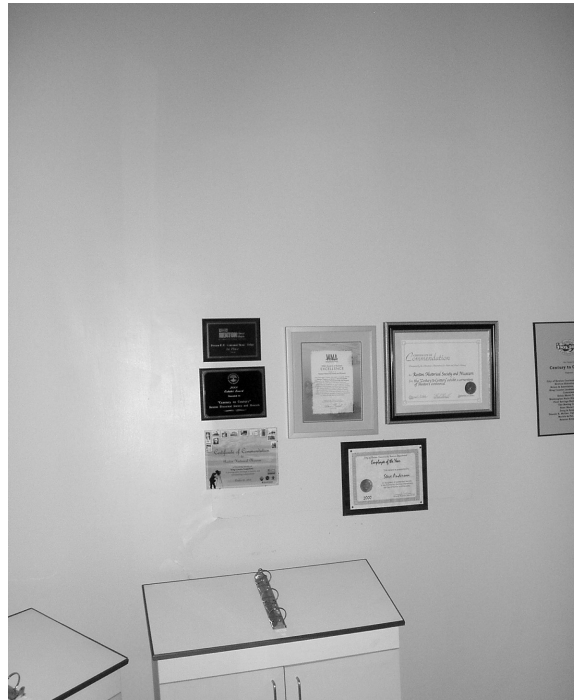
**The “ghost” of the window corner is visible through the sheetrock – directly above table.
Photo by author.**

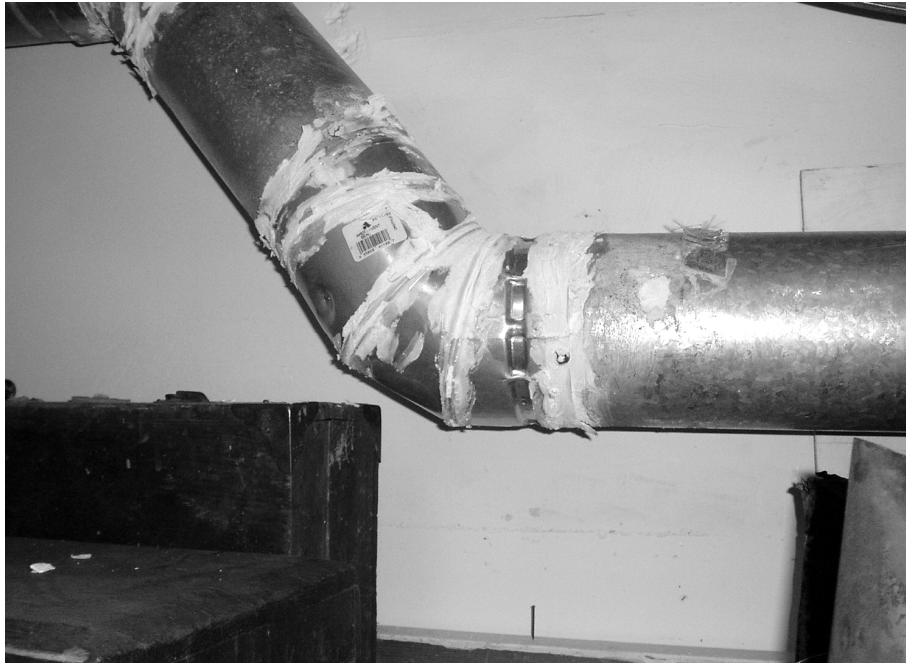
Collections Storage – exhaust duct over storage shelves exiting west wall – a nasty item to have in the collection room. Photo by author.
