COAL CAR HISTORIC RECONSTRUCTION

The Deconstruction of the Coal Car

March 14, 2008

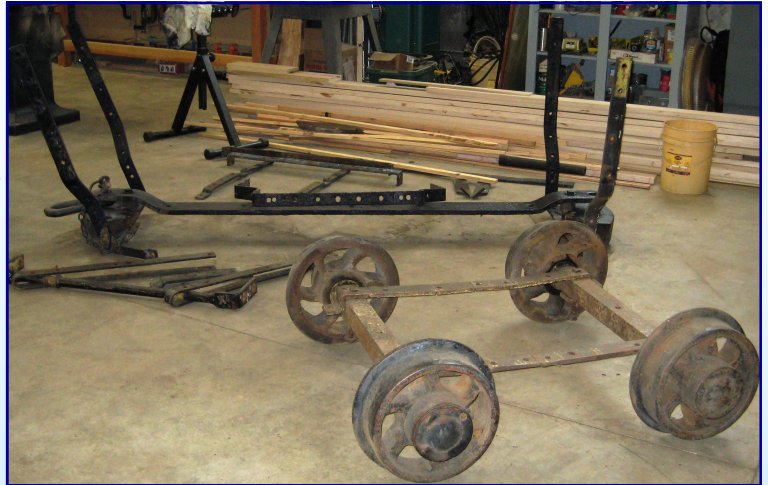
revealed a yellow coating on the underside of parts of the metal frame. Bill Hall identified this yellow coating as zinc chromate, an industrial primer historically used to coat the surfaces of metal in order to prevent corrosion.

The metal frame and wheelbase of the coal car. The old damaged wood has been removed.

The treatment of the metal frame and truck of the coal car involves brushing off the current coating of rust and applying a new primer. This new primer is black and chemically changes the surface of

the metal so that it will no longer be susceptible to corrosion. After the metal has been coated with the primer, a new coating of black paint will be applied. The photo at left shows a portion of the metal frame undergoing treatment. The vertical bar on the left has not yet been treated and is still covered in rust. The center portion and right vertical bar have had the rust removed and primer applied.
