Renton Historical Museum - RFQ Questions and Responses

Addendum One - August 1, 2025

**Renton Historical Museum Remodel
235 Mill Avenue South
Renton, WA 98057**

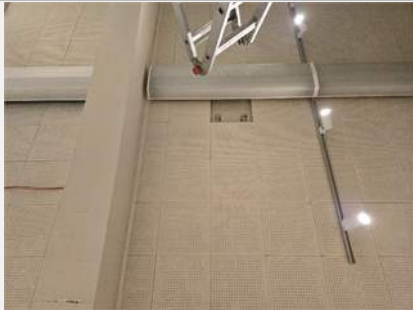
Asbestos Sample		Sample Date: 13-Nov-2024	
Project Name	Renton Historical Museum Remodel		
Sample Type	Physical Sample	AHERA Category	Miscellaneous
Sample Number	01	Homogeneous Material #	1
Material Description	Acoustical Ceiling Tile and mastic		
Building Component	Ceiling	Substrate	Plaster
Homogen. Mtl Area	N/A		
Sample Location	Room 110		
Quantity	700	Unit of Measure	Square Feet
Asbestos Type/%	None Detected (Both Layers)		
Sample Photo

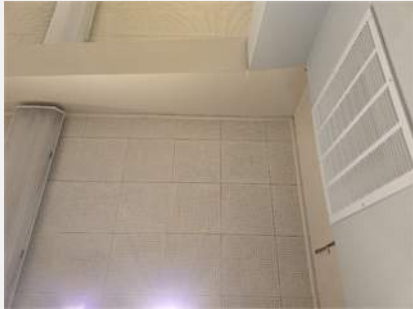
Asbestos Sample		Sample Date: 13-Nov-2024	
Project Name	Renton Historical Museum Remodel		
Sample Type	Physical Sample	AHERA Category	Miscellaneous
Sample Number	02	Homogeneous Material #	1
Material Description	Acoustical Ceiling Tile and mastic		
Building Component	Ceiling	Substrate	Plaster
Homogen. Mtl Area	N/A		
Sample Location	Room 110		
Quantity	See 01	Unit of Measure	Square Feet
Asbestos Type/%	None Detected (Both Layers)		
Sample Photo

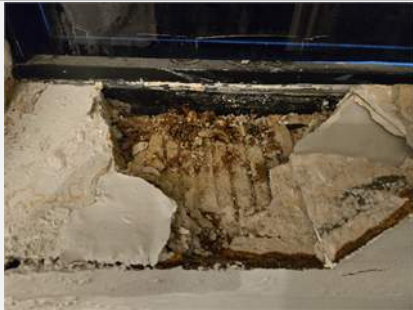
Asbestos Sample		Sample Date: 13-Nov-2024	
Project Name	Renton Historical Museum Remodel		
Sample Type	Physical Sample	AHERA Category	Surfacing
Sample Number	03	Homogeneous Material #	2
Material Description	Hard Plaster Wall tan scratch coat		
Building Component	Wall	Substrate	Concrete
Homogen. Mtl Area	N/A		
Damage Assessment	Damaged		
Sample Location	Room 110		
Quantity	10	Unit of Measure	Square Feet
Asbestos Type/%	None Detected		
Sample Photo

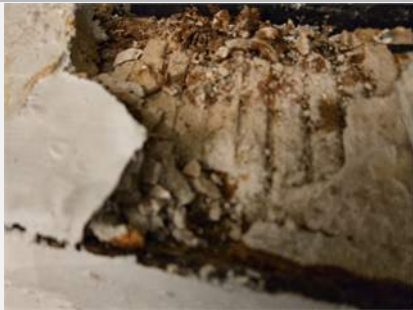
Asbestos Sample		Sample Date: 13-Nov-2024	
Project Name	Renton Historical Museum Remodel		
Sample Type	Physical Sample	AHERA Category	Surfacing
Sample Number	04	Homogeneous Material #	2
Material Description	Hard Plaster Wall tan scratch coat		
Building Component	Wall	Substrate	Concrete
Homogen. Mtl Area	N/A		
Sample Location	Room 110		
Quantity	See 03	Unit of Measure	Square Feet
Asbestos Type/%	None Detected		
Sample Photo

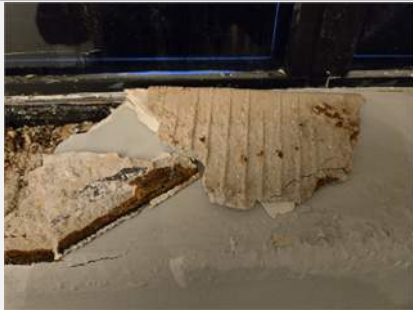
Asbestos Sample		Sample Date: 13-Nov-2024	
Project Name	Renton Historical Museum Remodel		
Sample Type	Physical Sample	AHERA Category	Surfacing
Sample Number	05	Homogeneous Material #	3
Material Description	Hard Plaster Wall white finish coat		
Building Component	Wall	Substrate	Concrete
Homogen. Mtl Area	N/A		
Damage Assessment	Damaged		
Sample Location	Room 110		
Quantity	10	Unit of Measure	Square Feet
Asbestos Type/%	None Detected		
Sample Photo

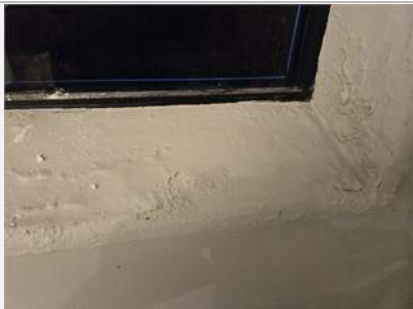
Asbestos Sample		Sample Date: 13-Nov-2024	
Project Name	Renton Historical Museum Remodel		
Sample Type	Physical Sample	AHERA Category	Surfacing
Sample Number	06	Homogeneous Material #	3
Material Description	Hard Plaster Wall white finish coat		
Building Component	Wall	Substrate	Concrete
Homogen. Mtl Area	N/A		
Sample Location	Room 110		
Quantity	See 05	Unit of Measure	Square Feet
Asbestos Type/%	None Detected		
Sample Photo

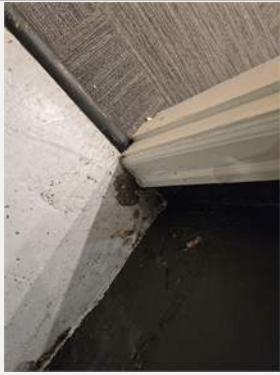
Asbestos Sample		Sample Date: 13-Nov-2024	
Project Name	Renton Historical Museum Remodel		
Sample Type	Physical Sample	AHERA Category	Surfacing
Sample Number	07	Homogeneous Material #	4
Material Description	Coating on concrete floor		
Building Component	Floor	Substrate	Concrete
Homogen. Mtl Area	N/A		
Sample Location	Room 109		
Quantity	2000	Unit of Measure	Square Feet
Asbestos Type/%	None Detected		
Sample Photo

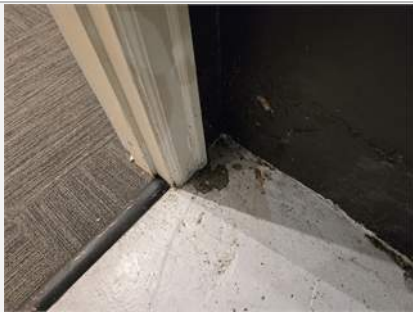
Asbestos Sample		Sample Date: 13-Nov-2024	
Project Name	Renton Historical Museum Remodel		
Sample Type	Physical Sample	AHERA Category	Surfacing
Sample Number	08	Homogeneous Material #	4
Material Description	Coating on concrete floor		
Building Component	Floor	Substrate	Concrete
Homogen. Mtl Area	N/A		
Sample Location	Room 109		
Quantity	See 07	Unit of Measure	Square Feet
Asbestos Type/%	None Detected		
Sample Photo

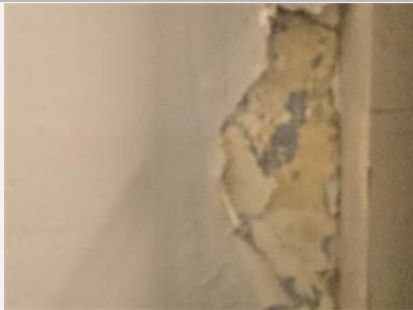
Asbestos Sample		Sample Date: 13-Nov-2024	
Project Name	Renton Historical Museum Remodel		
Sample Type	Physical Sample	AHERA Category	Surfacing
Sample Number	09	Homogeneous Material #	5
Material Description	Coating on concrete wall		
Building Component	Wall	Substrate	Concrete
Homogen. Mtl Area	N/A		
Damage Assessment	Damaged		
Sample Location	Room 109		
Asbestos Type/%	None Detected		
Sample Photo

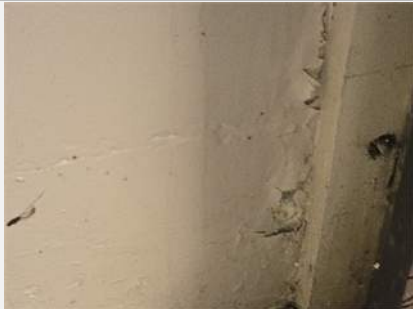
Asbestos Sample		Sample Date: 13-Nov-2024	
Project Name	Renton Historical Museum Remodel		
Sample Type	Physical Sample	AHERA Category	Surfacing
Sample Number	10	Homogeneous Material #	5
Material Description	Coating on concrete wall		
Building Component	Wall	Substrate	Concrete
Homogen. Mtl Area	N/A		
Damage Assessment	Damaged		
Sample Location	Room 109		
Asbestos Type/%	None Detected		
Sample Photo

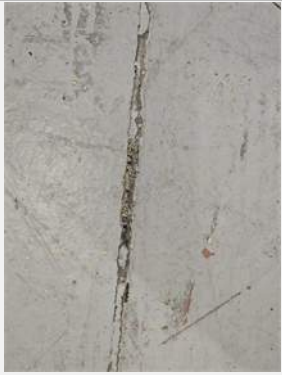
Asbestos Sample		Sample Date: 13-Nov-2024	
Project Name	Renton Historical Museum Remodel		
Sample Type	Physical Sample	AHERA Category	Miscellaneous
Sample Number	11	Homogeneous Material #	6
Material Description	Expansion Joint		
Building Component	Floor	Substrate	Concrete
Homogen. Mtl Area	N/A		
Sample Location	Room 109		
Quantity	70	Unit of Measure	Square Feet
Asbestos Type/%	None Detected		
Sample Photo

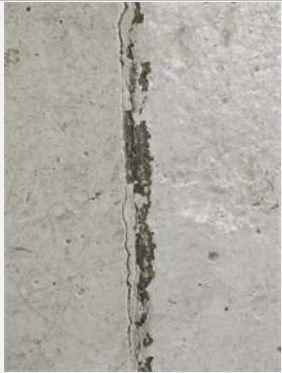
Asbestos Sample		Sample Date: 13-Nov-2024	
Project Name	Renton Historical Museum Remodel		
Sample Type	Physical Sample	AHERA Category	Miscellaneous
Sample Number	12	Homogeneous Material #	6
Material Description	Expansion Joint		
Building Component	Floor	Substrate	Concrete
Homogen. Mtl Area	N/A		
Sample Location	Room 109		
Quantity	See 11	Unit of Measure	
Asbestos Type/%	None Detected		
Sample Photo

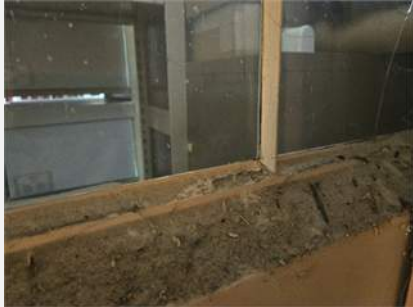
Asbestos Sample		Sample Date: 13-Nov-2024	
Project Name	Renton Historical Museum Remodel		
Sample Type	Physical Sample	AHERA Category	Miscellaneous
Sample Number	13	Homogeneous Material #	7
Material Description	Window Frame Caulk		
Building Component	Window	Substrate	Metal
Homogen. Mtl Area	N/A		
Sample Location	Stairs to basement		
Quantity	2	Unit of Measure	Each
Asbestos Type/%	None Detected		
Sample Photo

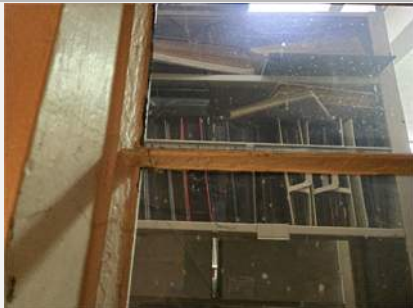
Asbestos Sample		Sample Date: 13-Nov-2024	
Project Name	Renton Historical Museum Remodel		
Sample Type	Physical Sample	AHERA Category	Miscellaneous
Sample Number	14	Homogeneous Material #	7
Material Description	Window Frame Caulk		
Building Component	Window	Substrate	Metal
Homogen. Mtl Area	N/A		
Sample Location	Stairs to basement		
Quantity	See 13	Unit of Measure	Each
Asbestos Type/%	None Detected		
Sample Photo

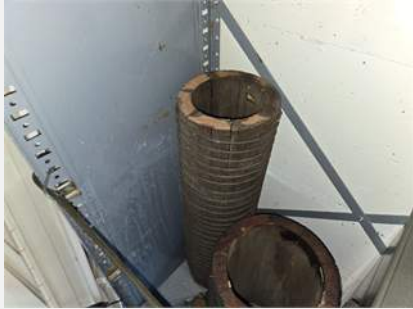
Asbestos Sample		Sample Date: 13-Nov-2024	
Project Name	Renton Historical Museum Remodel		
Sample Type	Physical Sample	AHERA Category	TSI
Sample Number	15	Homogeneous Material #	8
Material Description	Fiberglass pipe insulation		
Homogen. Mtl Area	N/A		
Sample Location	Room 109		
Quantity	100	Unit of Measure	Lineal Feet
Asbestos Type/%	None Detected (All Layers)		
Sample Photo

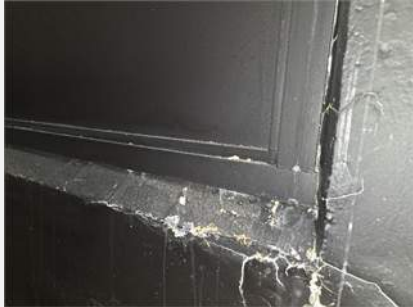
Asbestos Sample		Sample Date: 13-Nov-2024	
Project Name	Renton Historical Museum Remodel		
Sample Type	Physical Sample	AHERA Category	Surfacing
Sample Number	16	Homogeneous Material #	9
Material Description	Coating on concrete wall		
Building Component	Wall	Substrate	Concrete
Homogen. Mtl Area	N/A		
Sample Location	Room 109		
Asbestos Type/%	None Detected		
Sample Photo

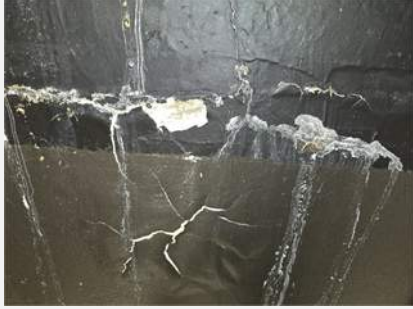
Asbestos Sample		Sample Date: 13-Nov-2024	
Project Name	Renton Historical Museum Remodel		
Sample Type	Physical Sample	AHERA Category	Surfacing
Sample Number	17	Homogeneous Material #	9
Material Description	Coating on concrete		
Building Component	Wall	Substrate	Concrete
Homogen. Mtl Area	N/A		
Sample Location	Room 109		
Asbestos Type/%	None Detected		
Sample Photo

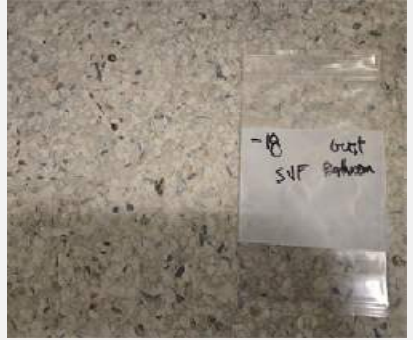
Asbestos Sample		Sample Date: 13-Nov-2024	
Project Name	Renton Historical Museum Remodel		
Sample Type	Physical Sample	AHERA Category	Miscellaneous
Sample Number	18	Homogeneous Material #	10
Material Description	Sheet Vinyl Flooring		
Building Component	Floor	Substrate	Concrete
Homogen. Mtl Area	N/A		
Sample Location	Guest restroom		
Quantity	74	Unit of Measure	Square Feet
Asbestos Type/%	None Detected (All Layers)		
Sample Photo

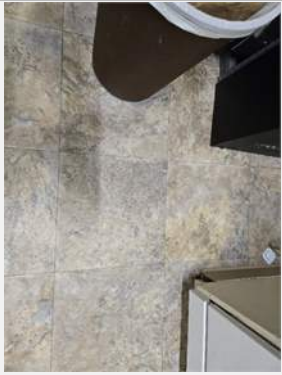
Asbestos Sample		Sample Date: 13-Nov-2024	
Project Name	Renton Historical Museum Remodel		
Sample Type	Physical Sample	AHERA Category	Miscellaneous
Sample Number	19	Homogeneous Material #	11
Material Description	Sheet Vinyl Flooring		
Building Component	Floor	Substrate	Concrete
Homogen. Mtl Area	N/A		
Sample Location	Kitchen		
Quantity	150	Unit of Measure	Square Feet
Asbestos Type/%	None Detected (All Layers)		
Sample Photo

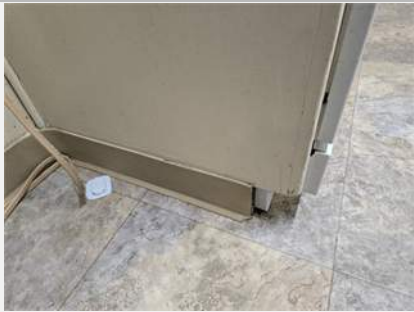
Asbestos Sample		Sample Date: 13-Nov-2024	
Project Name	Renton Historical Museum Remodel		
Sample Type	Physical Sample	AHERA Category	Miscellaneous
Sample Number	20	Homogeneous Material #	12
Material Description	Cove Base Mastic		
Building Component	Wall	Substrate	Wood
Homogen. Mtl Area	N/A		
Sample Location	Kitchen		
Quantity	40	Unit of Measure	Square Feet
Asbestos Type/%	None Detected (All Layers)		
Sample Photo

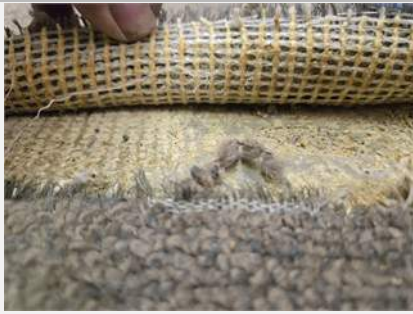
Asbestos Sample		Sample Date: 13-Nov-2024	
Project Name	Renton Historical Museum Remodel		
Sample Type	Physical Sample	AHERA Category	Miscellaneous
Sample Number	21	Homogeneous Material #	13
Material Description	Carpet Mastic		
Building Component	Floor	Substrate	Concrete
Homogen. Mtl Area	N/A		
Sample Location	Room 110		
Quantity	700	Unit of Measure	Square Feet
Asbestos Type/%	None Detected		
Sample Photo

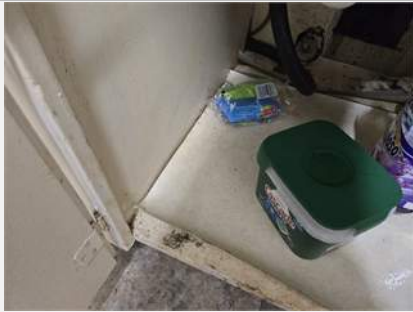
Asbestos Sample		Sample Date: 13-Nov-2024	
Project Name	Renton Historical Museum Remodel		
Sample Type	Physical Sample	AHERA Category	Miscellaneous
Sample Number	22	Homogeneous Material #	14
Material Description	Sink Undercoating		
Homogen. Mtl Area	N/A		
Sample Location	Kitchen		
Quantity	1	Unit of Measure	Each
Asbestos Type/%	None Detected		
Sample Photo

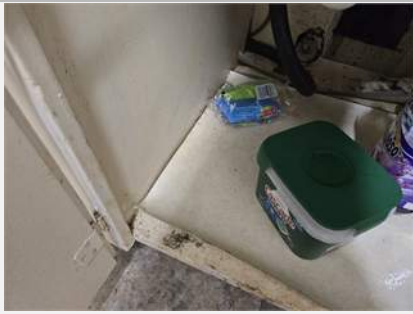
Asbestos Sample		Sample Date: 13-Nov-2024	
Project Name	Renton Historical Museum Remodel		
Sample Type	Physical Sample	AHERA Category	Miscellaneous
Sample Number	23	Homogeneous Material #	15
Material Description	Sheet Vinyl Flooring		
Building Component	Floor	Substrate	Wood
Homogen. Mtl Area	N/A		
Sample Location	Kitchen cabinet below sink		
Quantity	6	Unit of Measure	Square Feet
Asbestos Type/%	None Detected (Both Layers)		
Sample Photo

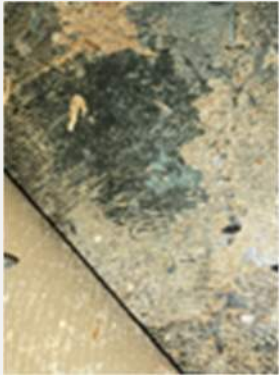
Asbestos Sample		Sample Date: 13-Nov-2024	
Project Name	Renton Historical Museum Remodel		
Sample Type	Physical Sample	AHERA Category	Miscellaneous
Sample Number	26	Homogeneous Material #	17
Material Description	Carpet Mastic		
Building Component	Floor	Substrate	Concrete
Homogen. Mtl Area	N/A		
Sample Location	Room 101		
Quantity	300	Unit of Measure	Square Feet
Asbestos Type/%	None Detected		
Sample Photo

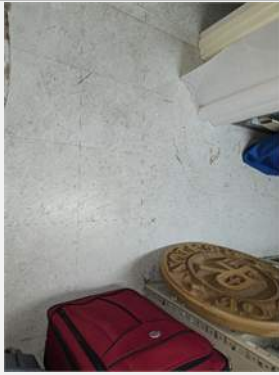
Asbestos Sample		Sample Date: 13-Nov-2024	
Project Name	Renton Historical Museum Remodel		
Sample Type	Physical Sample	AHERA Category	Miscellaneous
Sample Number	27	Homogeneous Material #	18
Material Description	12x12 Floor Tile		
Building Component	Floor	Substrate	Concrete
Homogen. Mtl Area	N/A		
Sample Location	Room 104		
Quantity	80	Unit of Measure	Square Feet
Asbestos Type/%	None Detected (Both Layers)		
Sample Photo

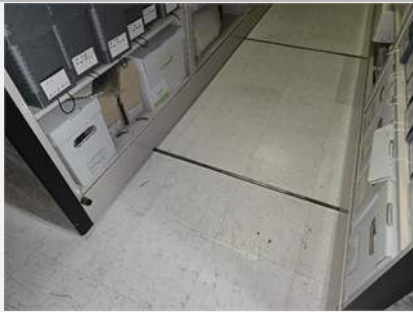
Asbestos Sample		Sample Date: 13-Nov-2024	
Project Name	Renton Historical Museum Remodel		
Sample Type	Physical Sample	AHERA Category	Miscellaneous
Sample Number	28	Homogeneous Material #	19
Material Description	12x12 Floor Tile		
Building Component	Floor	Substrate	Concrete
Homogen. Mtl Area	N/A		
Sample Location	Room 104 record storage		
Quantity	300	Unit of Measure	Square Feet
Asbestos Type/%	None Detected		
Sample Photo

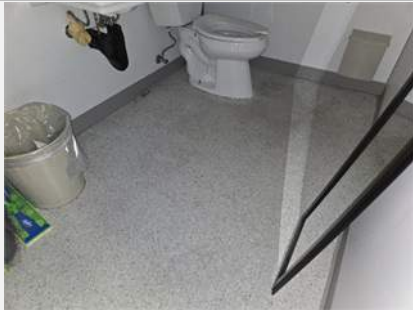
Asbestos Sample		Sample Date: 13-Nov-2024	
Project Name	Renton Historical Museum Remodel		
Sample Type	Physical Sample	AHERA Category	Miscellaneous
Sample Number	29	Homogeneous Material #	20
Material Description	Sheet Vinyl Flooring		
Building Component	Floor	Substrate	Concrete
Homogen. Mtl Area	N/A		
Sample Location	Employee restroom		
Quantity	100	Unit of Measure	Square Feet
Asbestos Type/%	None Detected (All Layers)		
Sample Photo

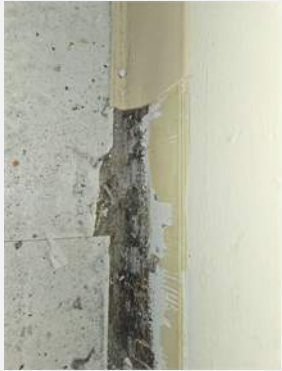
Asbestos Sample		Sample Date: 13-Nov-2024	
Project Name	Renton Historical Museum Remodel		
Sample Type	Physical Sample	AHERA Category	Miscellaneous
Sample Number	30	Homogeneous Material #	21
Material Description	9x9 Floor Tile under 12x12 tile		
Building Component	Floor	Substrate	Concrete
Homogen. Mtl Area	N/A		
Sample Location	Room 104		
Quantity	300	Unit of Measure	Square Feet
Asbestos Type/%	None Detected (All Layers)		
Sample Photo

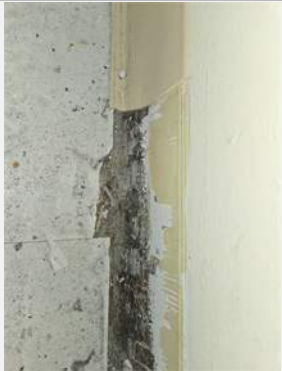
Asbestos Sample		Sample Date: 13-Nov-2024	
Project Name	Renton Historical Museum Remodel		
Sample Type	Physical Sample	AHERA Category	Miscellaneous
Sample Number	31	Homogeneous Material #	21
Material Description	9x9 Floor Tile under 12x12 tile		
Building Component	Floor	Substrate	Concrete
Homogen. Mtl Area	N/A		
Sample Location	Room 104		
Quantity	See 30	Unit of Measure	Square Feet
Asbestos Type/%	None Detected (All Layers)		
Sample Photo

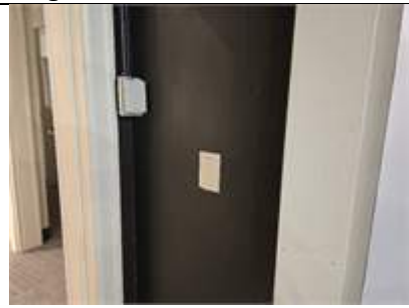
Lead Samples	
Sample Number	-117
Calibration	No
Substrate Description	Concrete
Component	Wall
Color	Black
Sample Location	Room 1
XRF Reading (Mg/cm2 lead)	0.55
Result	Negative
Sample Photo

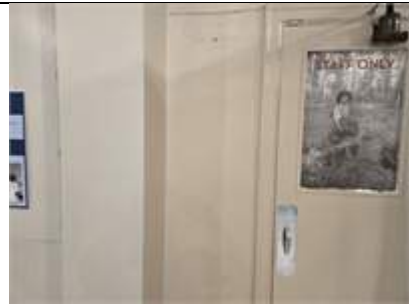
Lead Samples	
Sample Number	-121
Calibration	No
Substrate Description	Concrete
Component	Wall
Color	Beige
Sample Location	Room 1
XRF Reading (Mg/cm2 lead)	0.68
Result	Negative
Sample Photo

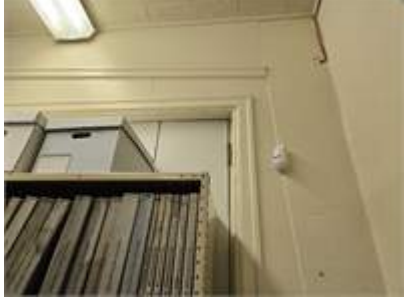
Lead Samples	
Sample Number	-126
Calibration	No
Substrate Description	Wood
Component	Door trim
Color	White
Sample Location	Office
XRF Reading (Mg/cm2 lead)	0.20
Result	Negative
Sample Photo

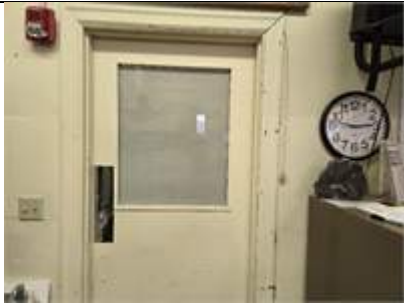
Lead Samples	
Sample Number	-127
Calibration	No
Substrate Description	Wood
Component	Door trim
Color	White
Sample Location	Office
XRF Reading (Mg/cm2 lead)	0.61
Result	Negative
Sample Photo

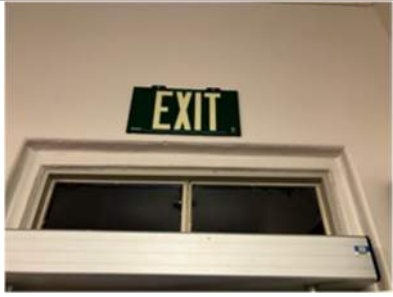
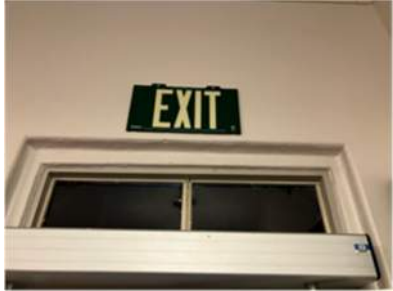
Universal Waste Sample		Sample Date: 17-May-2024	
Project Name	Renton Historical Museum Remodel		
Sample Type	Universal Waste		
Sample Number	UW-01		
Material Description	Exit signs		
Quantity	5	Unit of Measure	Each
Sample Photo

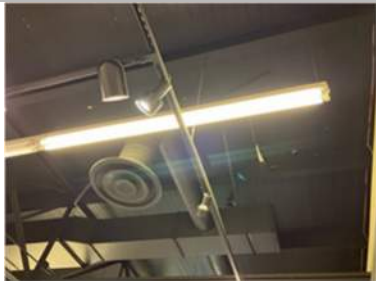
Universal Waste Sample		Sample Date: 17-May-2024	
Project Name	Renton Historical Museum Remodel		
Sample Type	Universal Waste		
Sample Number	UW-02		
Material Description	8-foot 2-tube fluorescent lights		
Quantity	12	Unit of Measure	Each
Sample Photo

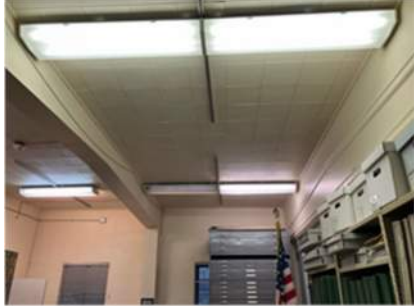
Universal Waste Sample		Sample Date: 17-May-2024	
Project Name	Renton Historical Museum Remodel		
Sample Type	Universal Waste		
Sample Number	UW-03		
Material Description	4-foot 4-tube fluorescent lights		
Quantity	12	Unit of Measure	Each
Sample Photo

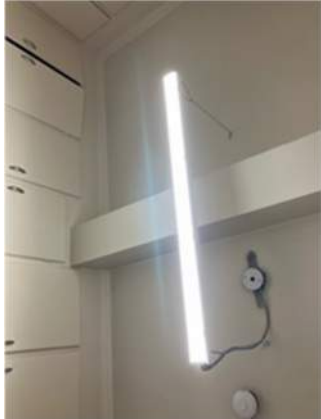
Universal Waste Sample		Sample Date: 18-May-2024	
Project Name	Renton Historical Museum Remodel		
Sample Type	Universal Waste		
Sample Number	UW-04		
Material Description	4-foot 1-tube electric lights		
Quantity	2	Unit of Measure	Each
Sample Photo

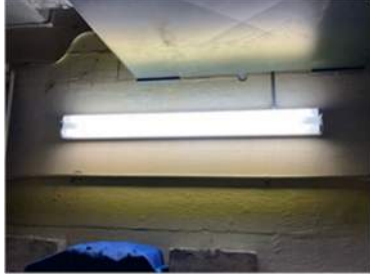
Universal Waste Sample		Sample Date: 18-May-2024	
Project Name	Renton Historical Museum Remodel		
Sample Type	Universal Waste		
Sample Number	UW-05		
Material Description	4-foot 2-tube fluorescent lights		
Quantity	4	Unit of Measure	Each
Sample Photo

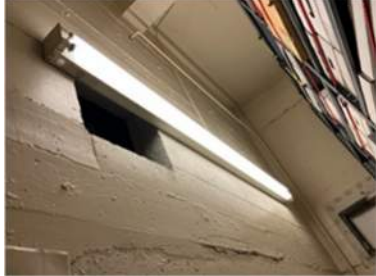
Universal Waste Sample		Sample Date: 18-May-2024	
Project Name	Renton Historical Museum Remodel		
Sample Type	Universal Waste		
Sample Number	UW-06		
Material Description	8-foot 2-tube fluorescent lights		
Quantity	1	Unit of Measure	Each
Sample Photo

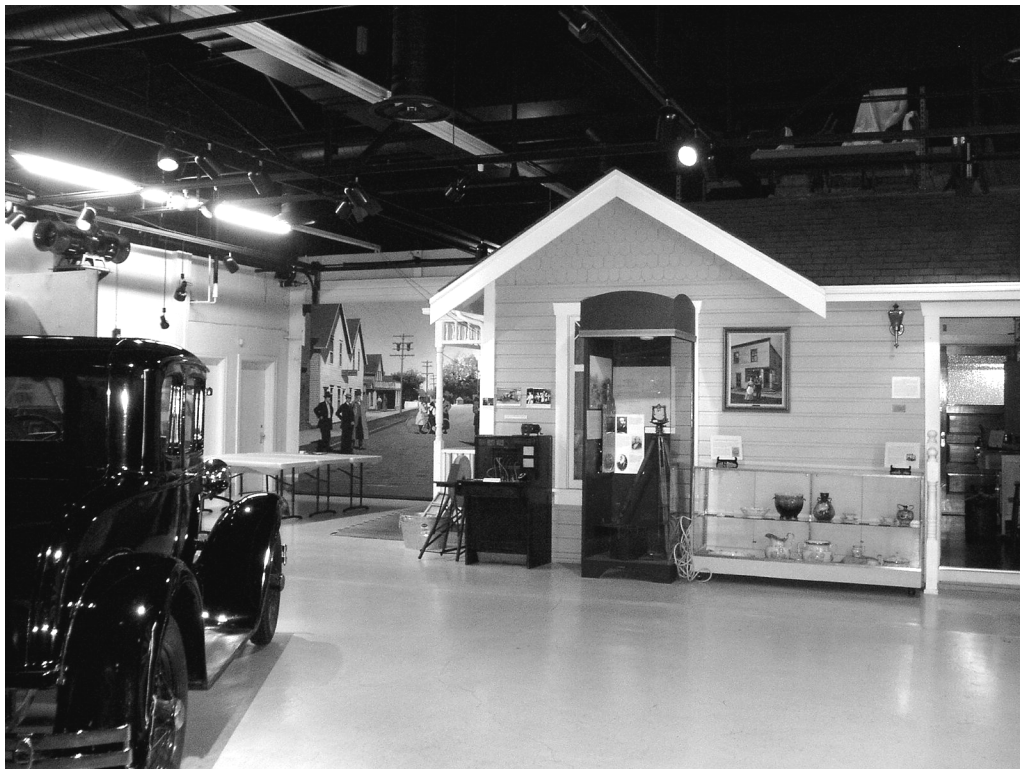
- O The 1920s house has some artifacts stored on the roof and porch roof.
- R Move those artifacts off the roofs!

**The Large Exhibit Hall displaying artifacts large and small, is a flexible space.
Photo by author.**
